**DEPARTMENT OF TRANSPORTATION**

Contract #: 04-0120F4Cty: SF/ALA Rte: 80 PM: 13.2/13.9File #: 99.28**WELDING INSPECTION REPORT****Resident Engineer:** Siegenthaler, Peter**Address:** 333 Burma Road**City:** Oakland, CA 94607**Report No:** WIR-019501**Date Inspected:** 18-Jan-2011**Project Name:** SAS Superstructure**OSM Arrival Time:** 700**Prime Contractor:** American Bridge/Fluor Enterprises, a JV**OSM Departure Time:** 1900**Contractor:** Zhenhua Port Machinery Company, Ltd (ZPMC) Chanxing Island**Location:** Shanghai, China**CWI Name:** Mr. Qui Wen**CWI Present:** Yes No**Inspected CWI report:** Yes No N/A**Rod Oven in Use:** Yes No N/A**Electrode to specification:** Yes No N/A**Weld Procedures Followed:** Yes No N/A**Qualified Welders:** Yes No N/A**Verified Joint Fit-up:** Yes No N/A**Approved Drawings:** Yes No N/A**Approved WPS:** Yes No N/A**Delayed / Cancelled:** Yes No N/A**Bridge No:** 34-0006**Component:** OBG Segment**Summary of Items Observed:**

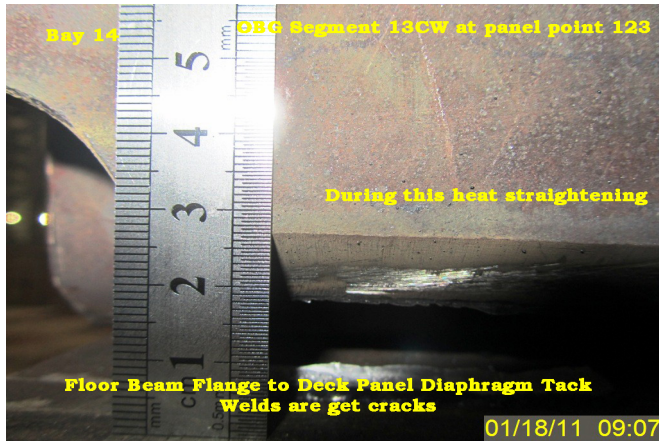
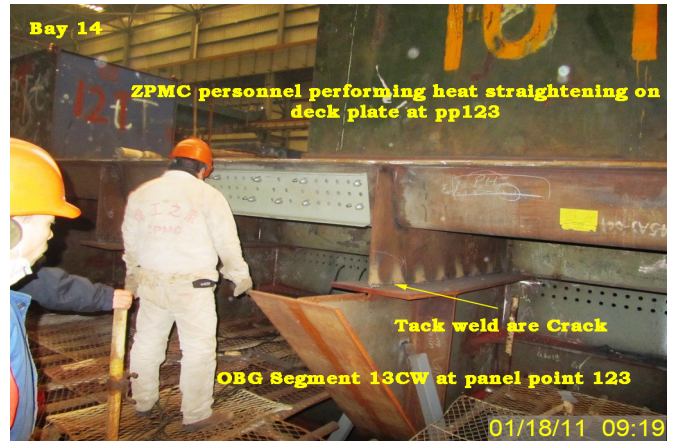
Description of Incident: During the Quality Assurance random visual inspection of welds located on Segment 13CW at panel point 122.5 to 124, this Quality Assurance Inspector (QA) observed ZMPC personnel performing heat straightening on Floor beam to deck panel diaphragm weld, during this heat straightening at panel point 123 the Floor Beam Flange to Deck Panel Diaphragm Tack Welds are get cracks. It happens at pp122.5, pp123 and 123.4 counter weight side. This weld is a Complete Joint Penetration (CJP) weld joining the floor beam flange to deck panel diaphragm. The floor beam flange to deck panel diaphragm weld is identified as SPCM. This weld is designated as Seismic Performance Critical Member (SPCM). OBG segment 13CW is located West Side of Bay 14 area. The ZPMC QC is identified as Mr. Li Ming Yang. QA inform to ZPMC that prior to the repair welding, to prepare CWR and ensure with VT and MT all defect have been removed. See the attaché picture.
